Chapter 4. Hydrometeorological conditions during the 10–12 November 2007 catastrophic storm, chronology of events, administrative actions taken and consequences of the disaster

Ovsienko S., *Fashchuk D.*, *Zatsepa S.*, *Ivchenko A.*, *Petrenko O.*, *Kabatchenko I.*, *Filippov Yu.*, *Yurenko Yu.*, *Ilyin Yu.*, *Chernov V.*

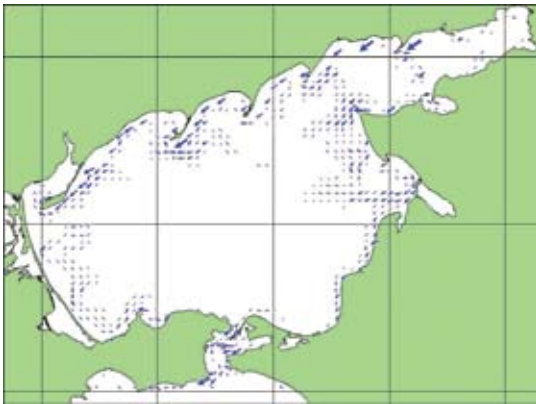
Fig. 4.3d. The field of water flow in the Kerch Strait and adjacent water areas of the Azov and the Black Seas at 12:00 AM (Moscow time) on 18 November 2007.

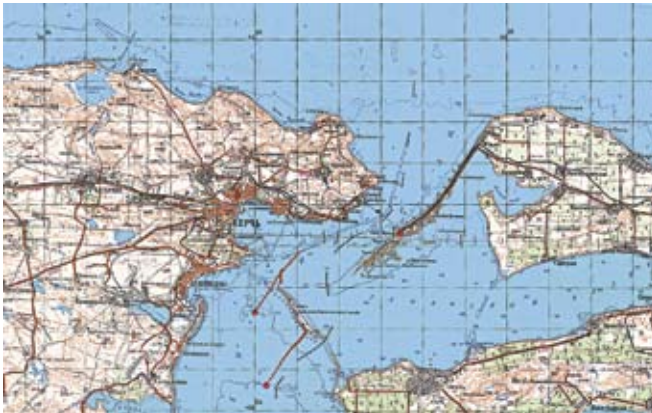
Fig. 4.5a. Oil spill six hours after the *Volgoneft-139* tanker accident on 11 November 2007, 10:00 Moscow time, the 210° wind — 20 m/sec.

A reconstruction of the aforementioned *Volgoneft-139* tanker accident looks as follows: Under a stormy South-South-Western wind impact, the oil slick hit the Tuzla Island's Southern coast six hours after the accident had occurred. The oil got partially detained by the Tuzla Island to concentrate by its South-Western coast, while a part of spill started moving around the island from the South-West to proceed spreading through the Pavlov Insularity in the direction of the Chushka Spit and the Azov Sea (Fig. 4.5a).

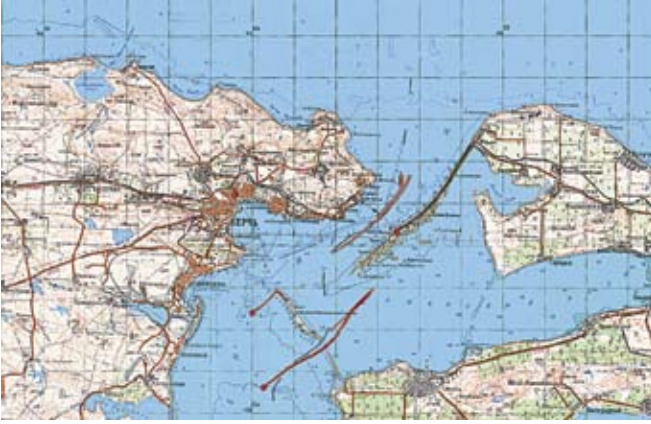
Fig. 4.5b. Oil spill 12 hours after the catastrophe on 11 November 2007, 16:00 Moscow time, the 240° wind — 10 m/sec.

By mid-day on 11 November (12:00 Moscow time) the spreading oil reached the entrance to the Azov Sea and started spreading to the East to the Chushka Spit coast affected by the wind that had taken a South-Western direction (Fig. 4.5b).

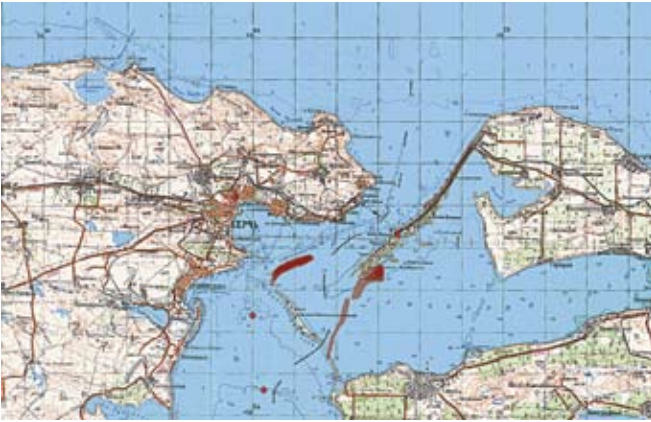
Fig. 4.5c. Oil spill 24 hours after the catastrophe on 12 November 2007, 4:00 Moscow time, a still wind.

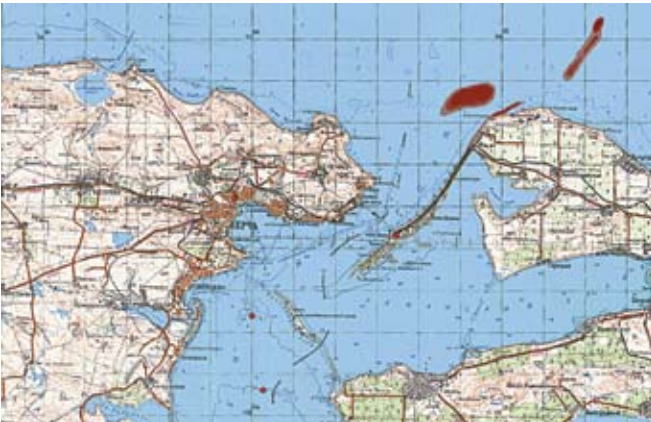
Fig. 4.5d. Oil spill 48 hours after the catastrophe on 13 November 2007, 4:00 Moscow time, the 310° wind — 5 m/sec.

In the afternoon on 12 November, the started South-Western wind (190–210°, 10–12 m/sec) tore-off the oil slick from the Chushka Spit coast and had almost brought it into the Azov Sea by 4 o'clock on 13 November (Fig. 4.5d). Still, starting from that

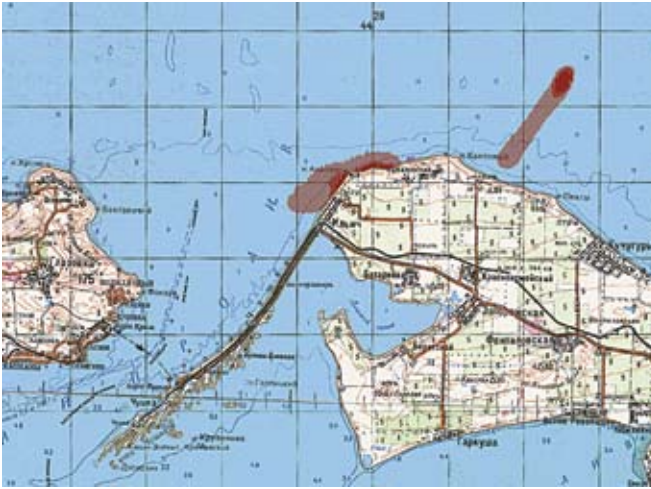
Fig. 4.5e. Oil spill 54 hours after the catastrophe on 13 November 2007, 9:00 Moscow time, the 320° wind — 5 m/sec.

moment its direction took a change to the South-West and by 9 o'clock on 13 November the oil slick having changed its direction into the opposite had hit the Taman Northern coast (Fig. 4.5e)

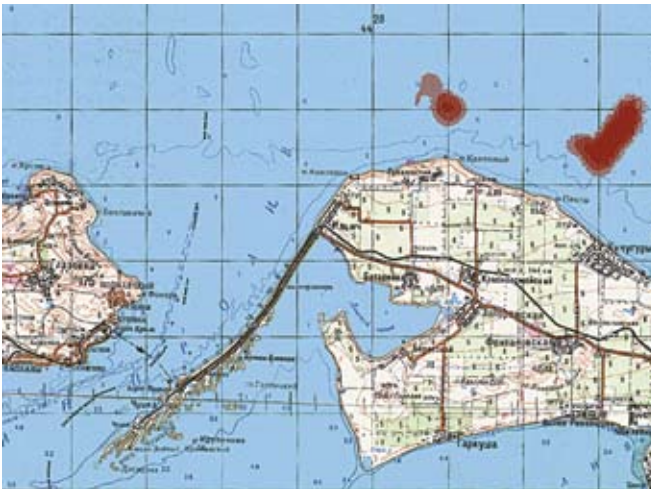
Fig. 4.5f. Oil spill 96 hours after the catastrophe on 15 November 2007, 3:00 Moscow time, the 100° wind — 3 m/sec.

In the afternoon on 13 November, the newly arrived still to practically last till the end of the day on 14 November, contributed to saving from oil pollution the Russian coast of the Azov Sea at the strait entrance. It was the Southern wind started on 15 November only that tore-off the oil slick from the shore to move it to the Azov Sea (Fig. 4.5f).

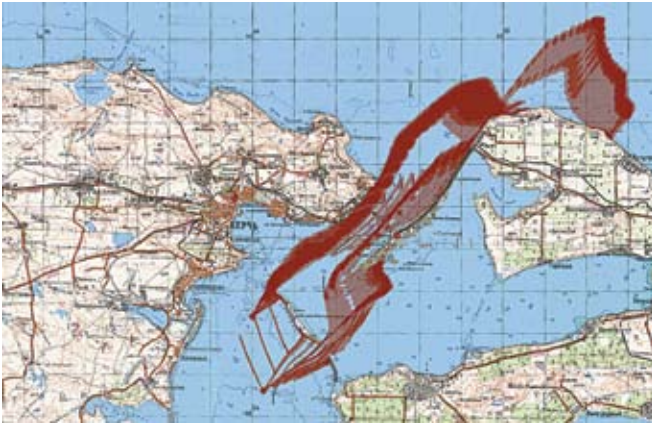
Fig. 4.5g. The Kerch Strait water space areas affected by the *Volgoneft-139* tanker oil spill on 11–15 November 2007.

The integrated picture of the Kerch Strait pollution during 11–15 November established based on the simulated model calculated results has shown the areas of the oil slick spread after the tanker accident (Fig. 4.5g). The oil was originally expected to spread largely by the sea surface. Nevertheless, the oil high density had to be taken into account due to which it could stay on the coast line elements, disperse in thick water and settle down to the strait bottom. All those mentioned had a potential to become a source of a long-term secondary pollution.

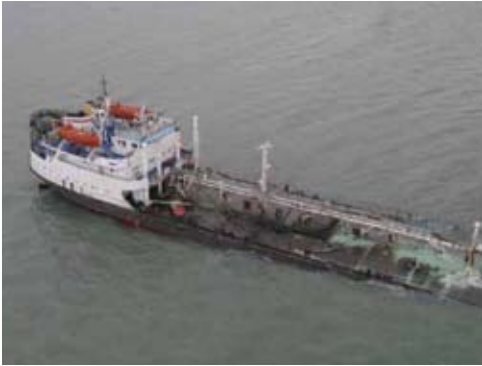
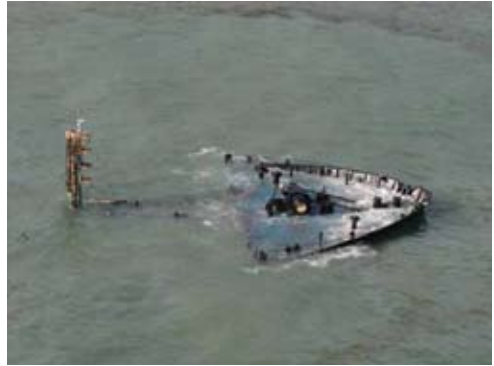
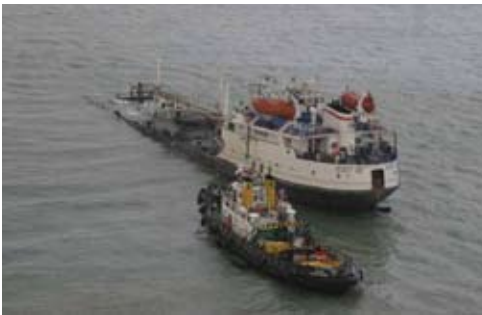
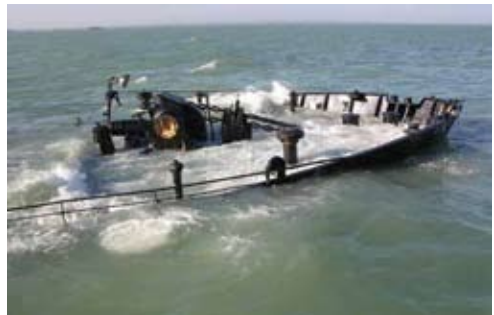
Photo. Parts of the *Volgoneft-139* tanker: the grounded stern, towed to Port Caucasus on 15 November 2007, and the bow removed on 13 August 2008 (www.yuga.ru, Booklet, 2009).

The *Volgoneft-139* tanker broke apart at its anchorage No 451 to the South from the Tuzla Island at 4:50 AM Moscow Time on 11 November 2007 causing leakage of heavy oil into the sea. Tanker's bow retained its position while the stern began drifting towards the Tuzla Island. The tanker had carried a total of 4777 tons of heavy oil, about 1300 out of which leaked into the sea. A strong wind and the waves contributed to spreading the oil products over the Strait resulting in the coastline heavy pollution.

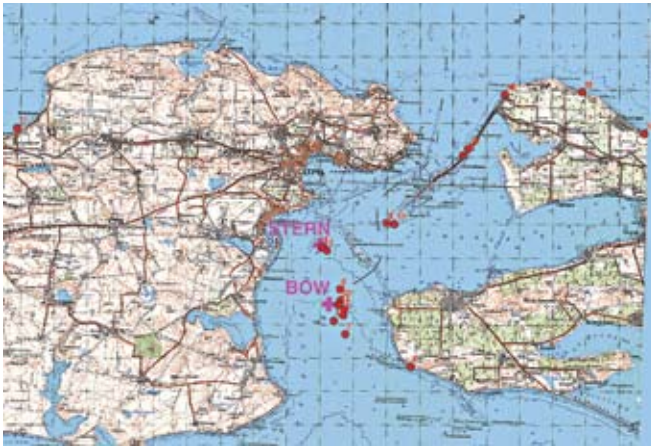
Fig. 4.6b. Results of a helicopter survey carried out by the Russian Ministry of Emergency Situations over the aftermath of the *Volgoneft-139* tanker accident in the Kerch Strait on 14 November 2007 at 10:00–12:00 in the morning. Numbers at the Figure correspond to the items in Table 4.6a.

jointly with mapping the oil slicks in the Strait water space and ashore (Table 4.6a, Fig. 4.6b).

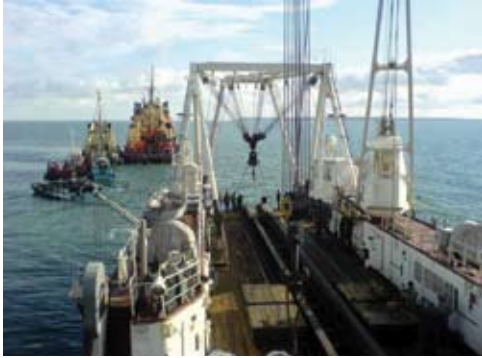
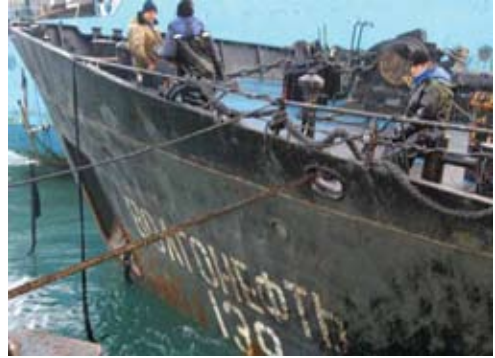
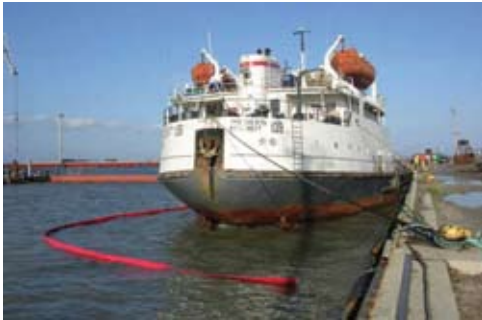
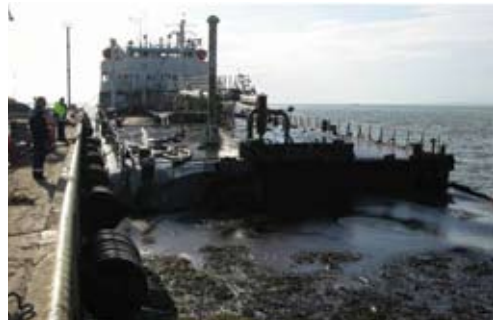
Photo: Raising operation of bow part and both bow and stern parts of *Volgoneft-139* in the port Caucasus (Booklet, 2009).

Later, on 14 August 2008 the *Volgoneft 139* tanker bow was recovered and towed to berth No 25 of the port of Caucasus. At present, it is being dismantled and recycled further.

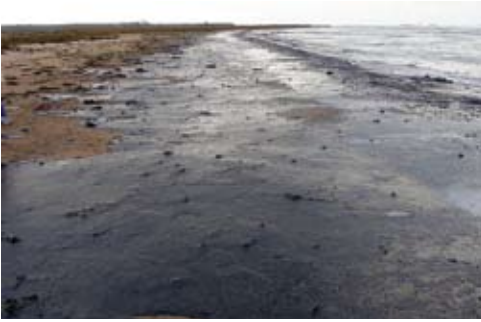
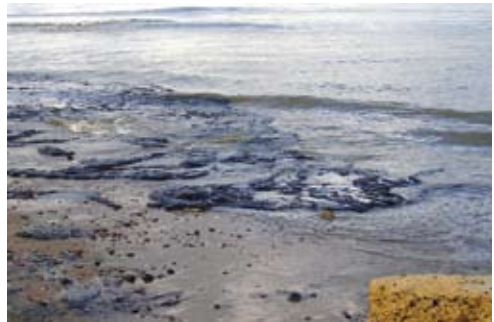
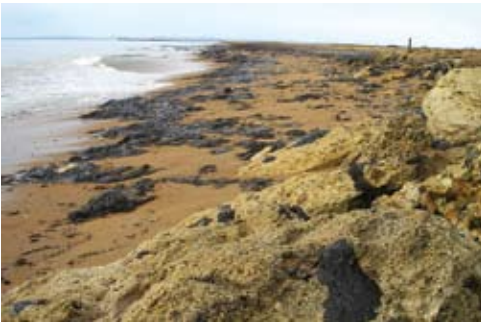
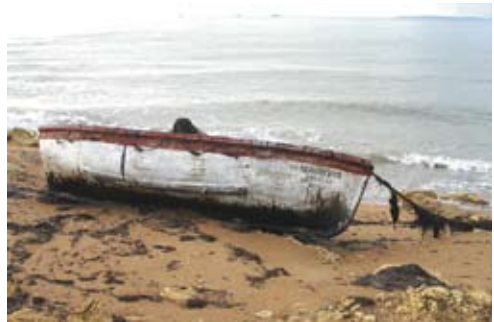
Photo: Oil spilled on the coast of the Tuzla Island, photo of *Igor Golubenkov* (NGO: Saving Taman), <http://www.flickr.com/photos/>.

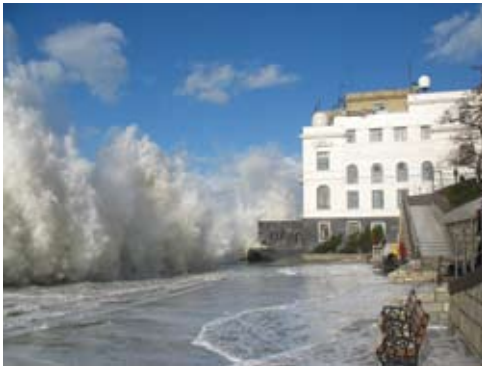
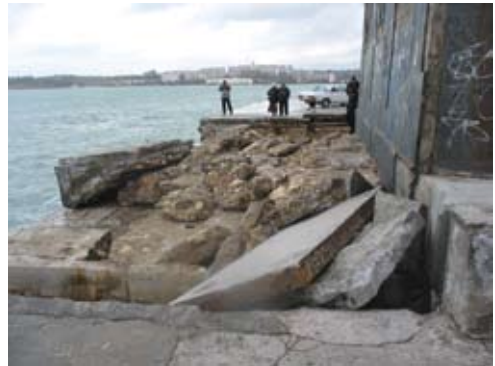
Photo: The storm on 11th of November 2007, Sevastopol, building of IBSS, and it's consequences on the next day. Photo by *Sergey Alyomov*.
